Chuck Hansen to Present New Standards for Testing Cured-In-Place Pipes as 'Watertight' at Australian No-Dig Conference

Electro Scan's Adoption Grows as Traditional Pipe Inspection Methods Fall Short of Testing Cured-In-Place Pipe for Watertightness and Locating Infiltration

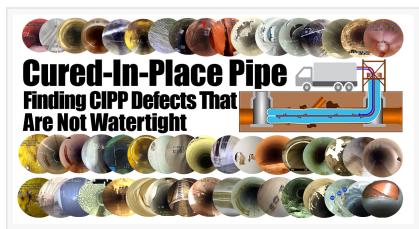
Widespread Use of Cured-In-Place Pipe (CIPP) for Trenchless Rehabilitation Results in Increase Demand for Early Warning QA/QC of Leaks, Pinholes, and Liner Permeability.

Accelerant Burns Equipment Damage
Accidental Cuts Foreign Objects
Bad Service Reconnections Low Resin-to-Felt Ratio
Blisters Pinholes
Defective Epoxy Poor Curing
Delamination Overcooking

Stretching
Top-Hat Defects
Wet-Out Failures
Wrinkles, including
Buckling, Fins, Folds,

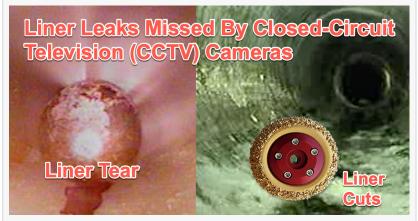
CIPP leaks not seen by visual inspection or CCTV cameras.

Leaks in CIPP liners missed by Closed-Circuit Television cameras which cannot determine watertightness.

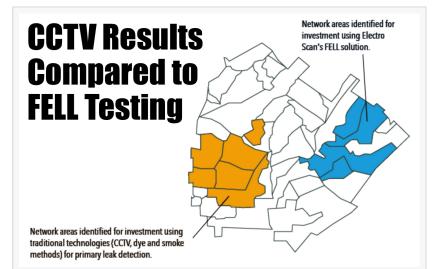
Traditional visual inspection using high resolution CCTV cameras miss the majority of leaks compared to machine-intelligent FELL test results that automatically locates and priorities leaks before and after rehabilitation.
