Maximizing electrical safety in the operating room

With the latest technology, hospital staff can efficiently prevent potential serious hazards early before damage occurs.

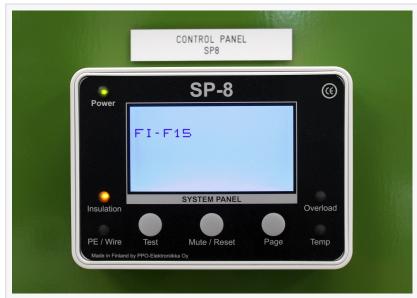
Insulation fault in the socket F15

Switchboards are often designed so that they are too small to fit the equipment of advanced IT equipment. A safe IT system should include insulation fault localization, protective conductor continuity measurement and a fault detection screen in the operating room. In practice, this means that the insulation fault locator indicates the location of the faulty device. Protective conductor continuity measurement ensures that protective earth is used at each socket. It is essential to understand that these sockets are not earthed if the protective earth is disconnected. These sockets will then not have insulation monitoring.

The ideal situation would be to monitor at the socket level. The faulty device could then be quickly localized and replaced.

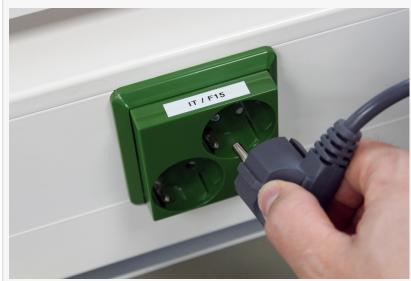
The staff have localized and replaced the faulty device.
