CIVIL ENGINEERS USE PUBLIC SATELLITE IMAGES TO STUDY WHY THE JAGERSFONTEIN DAM FAILED

Study by civil engineers at Wits University finds that the history of the Jagersfontein dam deviates from best engineering practice.

JOHANNESBURG, GAUTENG, SOUTH AFRICA, April 5, 2023

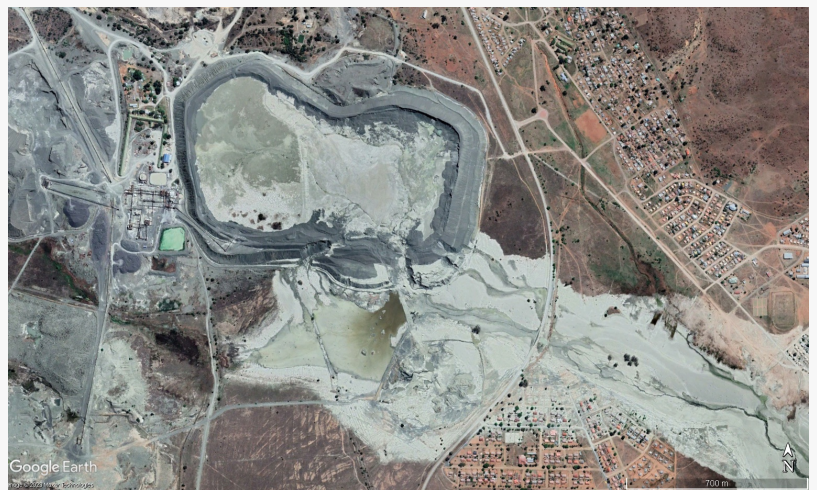
Post-failure satellite image of the Jagersfontein dam.
Source: Google Earth Pro
