# Laboratories Predict the Safe End-of-Life for Concrete Building Structures

*Learn about the role material testing labs play in investigating concrete structural failures and what you can do to keep them safe.*

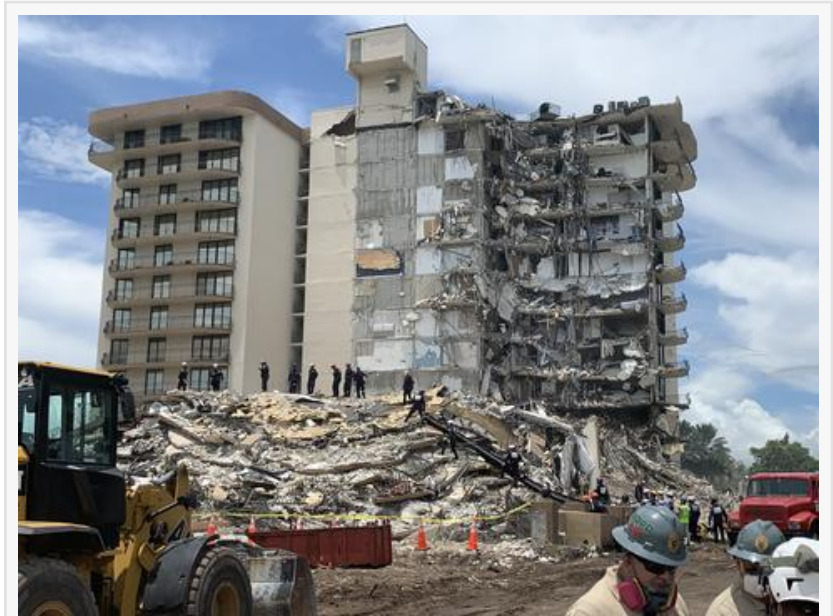
The site of the partially collapsed Champlain Towers South in Surfside, Florida. Image courtesy of NIST.

In June 2023, NIST officials presented their preliminary report on the Champlain Towers South collapse. The report was able to eliminate several potential causes of the collapse (including an explosion, or a vehicle impacting a support column in the parking structure), but a couple dozen hypotheses remain open for investigation.

Among these, NIST investigators are focused on areas of the original design that appear to provide only half of the structural strength required by 1981 building codes, poor placement of concrete rebar in the structure, the extra weight of heavy materials added to the building since it was constructed, and photographic evidence of major cracks and concrete spalling found in the months prior to the collapse.

NIST investigators are concerned that the concrete support piers of the Champlain Towers South building were built with inappropriate rebar connections to the poured concrete floor. In some cases, there may have been too little rebar, in other cases, the rebar may have been bunched too closely together, providing little room for the concrete to affix to the connection.
