ZD Stucco Repair Completes Full Restoration of a Gorgeous Mansion in Mendham, NJ

Stucco Restoration of Beautiful Mansion in Mendham, NJ

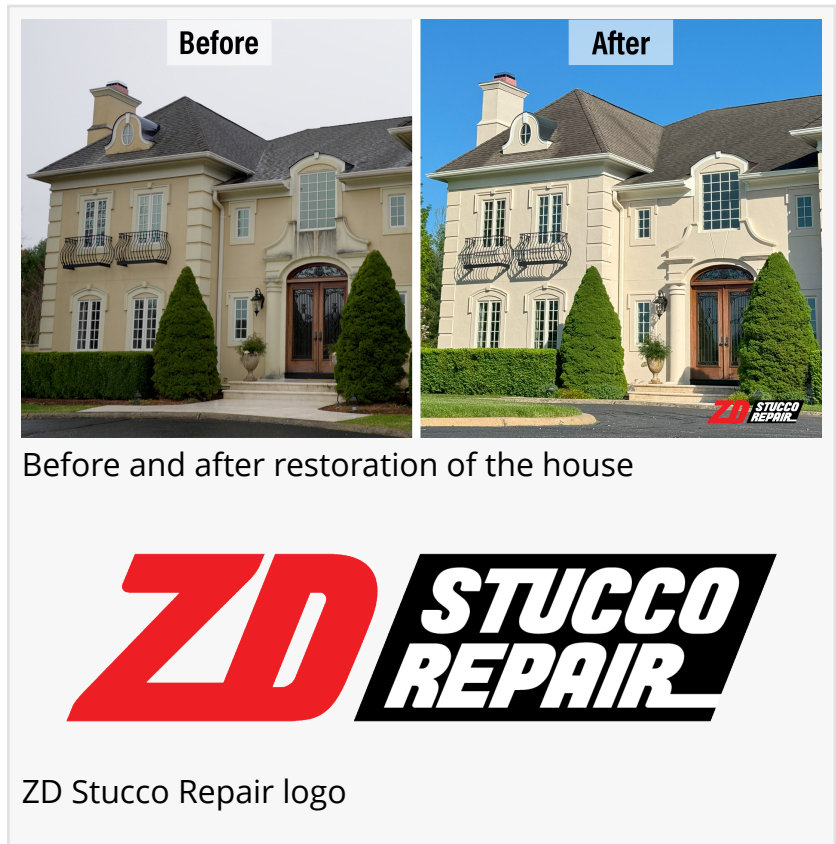
Before and after restoration of the house

- Chimney Repair: The chimney's visible cinder block marks, caused by a lack of protective layers beneath the old stucco, posed a significant challenge. The ZD team carefully addressed these imperfections, applying a fresh cement coat reinforced with fiberglass mesh to ensure

- Garden Wall Restoration: Loose stucco and cement on the garden walls required thorough attention. The ZD Stucco Repair team power-washed them and scraped off the loose materials, preparing the surfaces for a new coat of stucco.

- Seamless Texture Matching: Achieving a very close match with the existing stucco texture was a key focus. ZD specialists meticulously applied new stucco over the cement coat, blending it

perfectly with the original texture on the mansion and chimney.

- Crack and Damage Repair: Any missing or damaged areas were restored using textured caulking, ensuring that all cracks were filled and would become virtually invisible once painted.

- Moisture Protection: To safeguard against moisture intrusion, all windows, doors, light fixtures, and electrical outlets were sealed with high-performance elastic sealant.

- Elastomeric Painting: The final touch involved applying two coats of elastomeric stucco paint, which not only enhances the mansion's appearance but also provides flexibility and protection, preventing future cracks and deterioration.
