Study of Pre- and Post-Rehabilitation of Cured-In-Place Pipe for Florida Utility Shows 63% Increase in Infiltration

Landmark 4-Year Study of CCTV & FELL Inspections Confirms Major Problems Using Visual Inspection to Detect Infiltration or Certify Pipe Repairs as Watertight

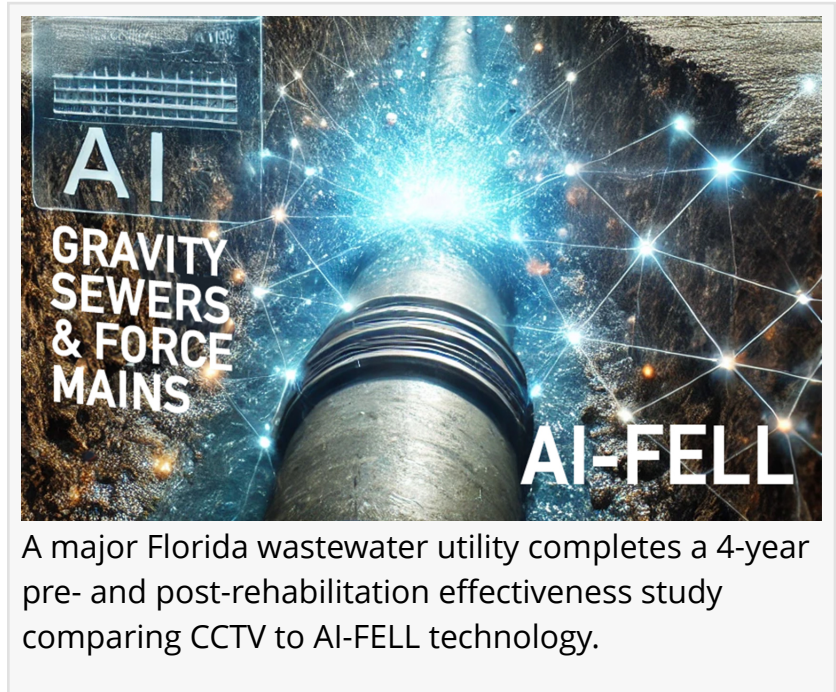
A major Florida wastewater utility completes a 4-year pre- and post-rehabilitation effectiveness study comparing CCTV to AI-FELL technology.

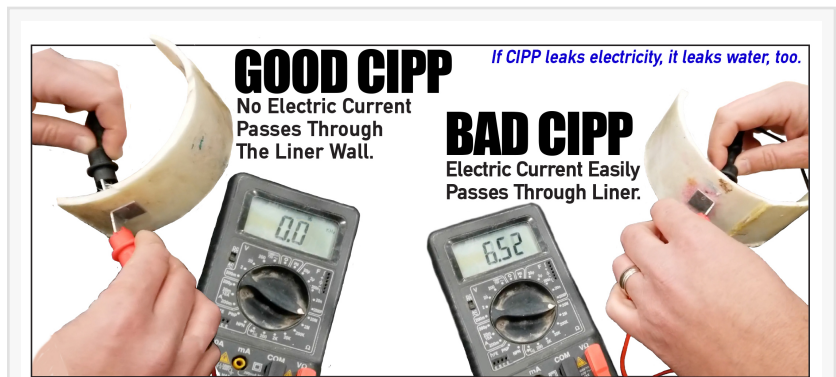
Low voltage conductivity allows utilities to automatically identify location and severity of defects in Cured-In-Place Pipe (CIPP) and other trenchless rehabilitation.

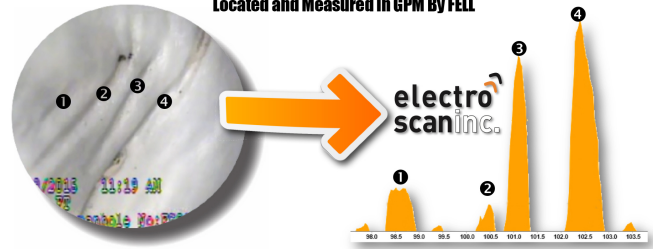
CIPP Wrinkles That Leak. Missed by CCTV.

Located and Measured in GPM By FELL

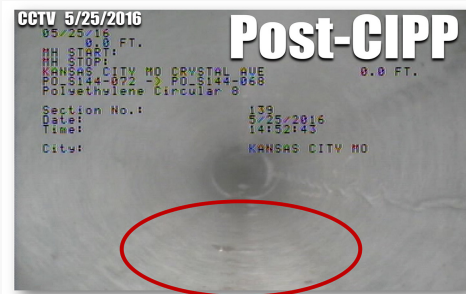
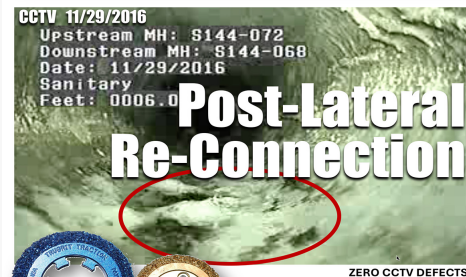
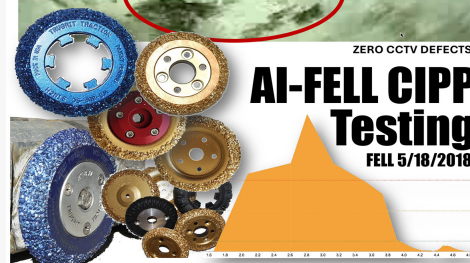
Missed by Closed-Circuit Television (CCTV) Cameras, New Standards Locate & Measure Leaks in Gallons per Minute or Liters per Second.

Another common reason for CIPP to leak more after rehabilitation is damage caused by Post-CIPP CCTV inspection and/or lateral reinstatement equipment.
