Stucco Problems Solved and a Whole New Look Unveiled in Eastern Pennsylvania

ZD Stucco Repair has completed a full-scale exterior restoration of a 4,900 sq ft luxury home located on a quiet cul-de-sac in Bethlehem, PA.

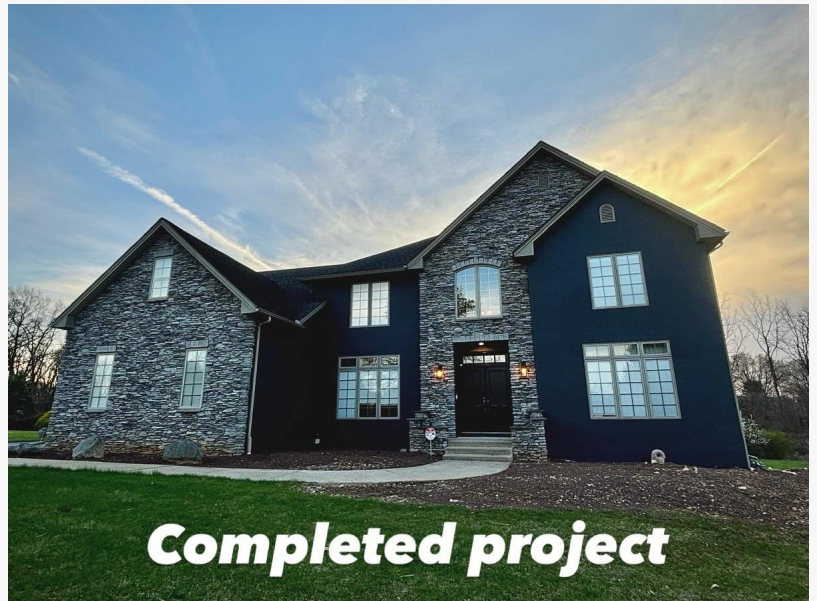
Completed stucco renovation project in Bethlehem, PA

The homeowner used the opportunity during the repairs to not only replace the stucco but also give the home a bold new look: a sleek black finish was chosen to complement the existing brick and windows with a modern, refined style. Before painting, all windows and fixtures were professionally sealed, and the entire home received a [paint finish](#) for long-term protection and curb appeal.

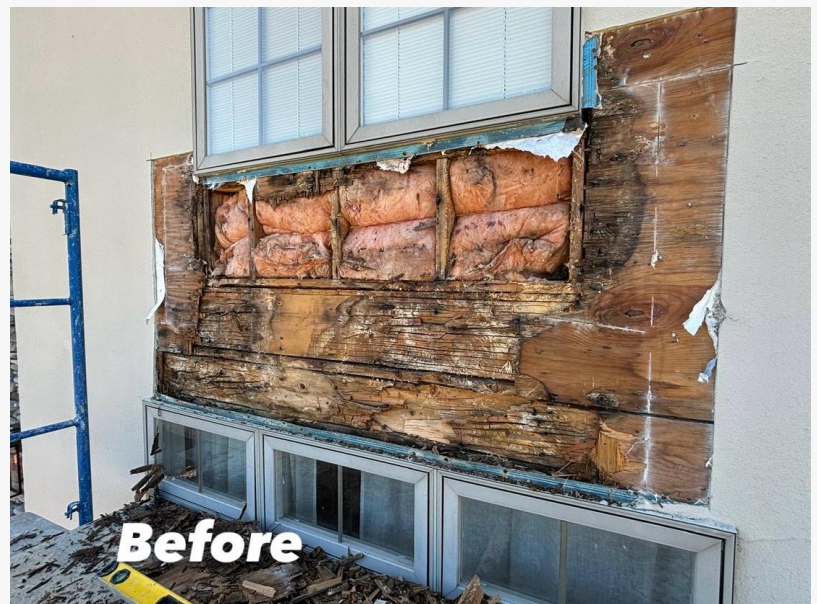
Our team uncovered major issues: failed head flashing, missing soft joints, no weepscreen, and trapped moisture behind the cladding. A quick patch wouldn't cut it - so in several places we had to remove the stucco system and install a new one that meets current American Society for Testing and Materials (ASTM) standards.

Open stucco system - before

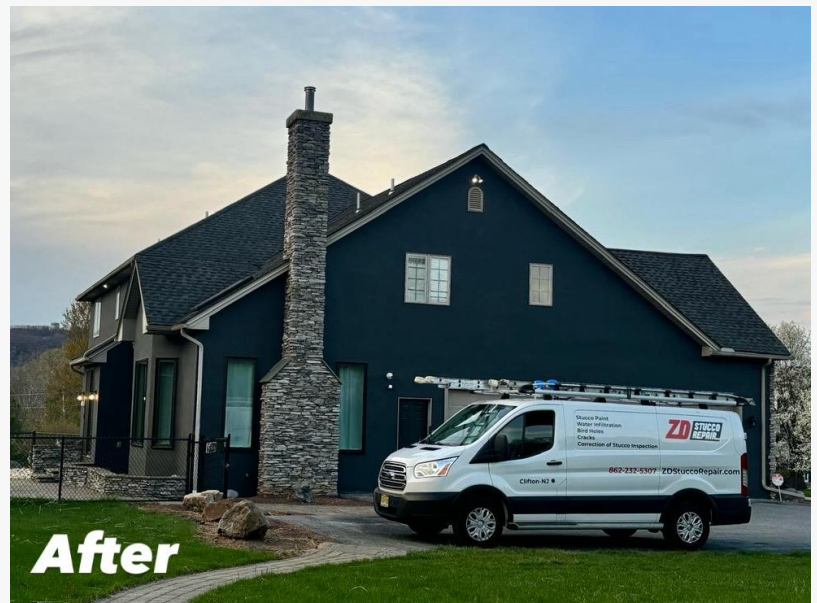
After image of stucco renovation project in Bethlehem, PA
