ZD Stucco Repair Repairs Hidden Water Damage Beneath Seemingly Clean Walls in Cresskill Community

ZD Stucco Repair uncovers hidden moisture issues during proactive repairs in Cresskill, helping homeowners restore and protect the value of their homes.

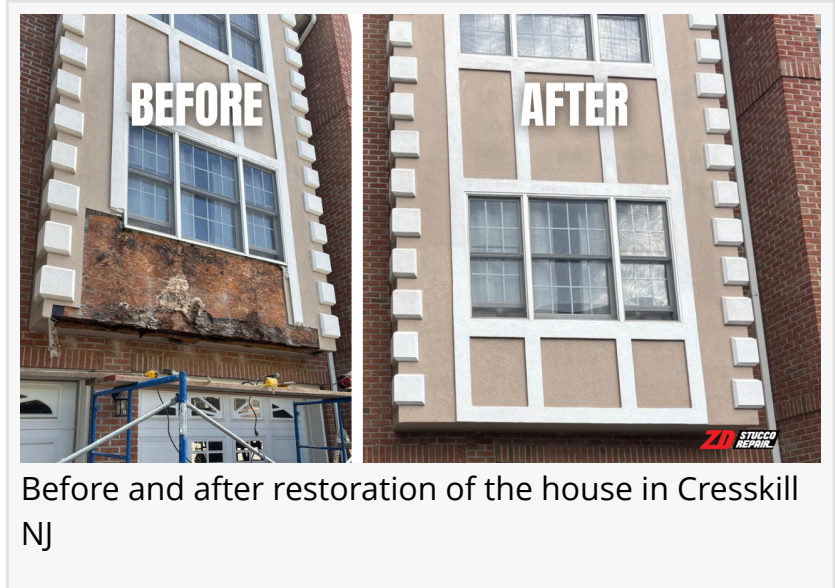
From the outside, the homes looked fine with only minor to no cracking. Nothing alarming. But once the stucco was removed, the crew found long-term [water intrusion](#), trapped behind walls for years. The underlying wood was soaked and deteriorating.

The root cause? Improperly sealed windows. Without effective moisture barriers or proper flashing during the original construction, water had slowly seeped into the structure.

ZD Stucco Repair staff working on repairing the rotted plywood in the stucco system

Once exposed, the ZD team moved fast. All compromised stucco and rotted plywood were removed. Every damaged section was replaced with new plywood which would provide structural support to the stucco system. The crews then installed a modern moisture protection system which used a breathable water membrane.

Over that, they applied a cement board layer. A base coat was layered over the board, reinforced with fiberglass mesh to add durability and resist future cracking. A final stucco coat was applied to blend with the existing exterior, making the repairs virtually invisible.

But the upgrade didn't stop there. Each damaged section was painted using a [premium-grade elastomeric coating](#). This flexible, weatherproof paint not only blends with the existing paint but also creates a breathable seal to protect the home from water and UV damage long-term. Each repaired home now includes a 5-year workmanship warranty to guarantee the stucco work will last.

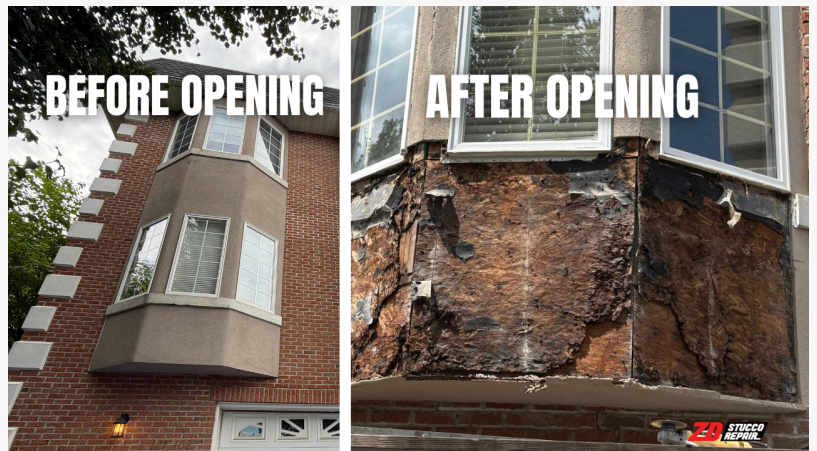
Before and after opening the stucco system
