# ZD Stucco Repair Completes Full Exterior Restoration of Historic Lake Mohawk Country Club

*Complex project combined traditional construction methods with modern exterior restoration while keeping the active clubhouse operational.*

SPARTA, NJ, UNITED STATES, June 8, 2026 /EINPresswire.com/ -- ZD Stucco Repair has completed a comprehensive exterior restoration of Lake Mohawk Country Club, a landmark 1930 clubhouse located in Sparta, New Jersey.

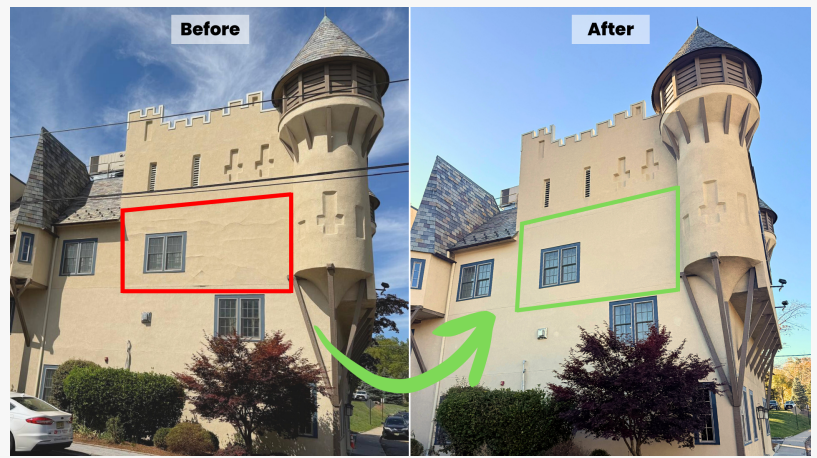
Before and After Stucco Wall Repair

Major cracks in the solid concrete chimney were repaired by resurfacing the affected areas with reinforced base coat and embedded fiberglass mesh. A new stucco finish was then applied and matched to the existing texture as closely as possible.

After the wood repairs, crack remediation, sealing and stucco restoration were completed, the exterior was finished with elastomeric stucco coating to provide a consistent appearance across the building.
