# ArmorThane urges pre-harvest bin lining to help curb grain-storage corrosion

SPRINGFIELD, MISSOURI, MO, UNITED STATES, July 8, 2026 / EINPresswire.com/ -- [ArmorThane](#) urges pre-harvest bin lining to help curb grain-storage corrosion

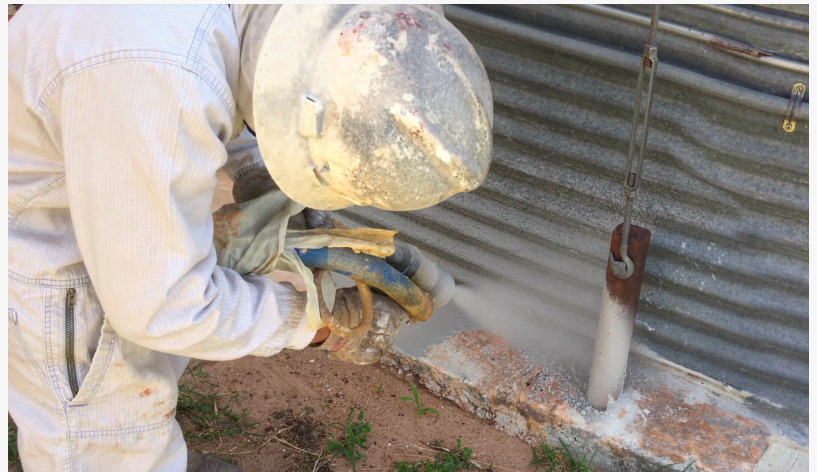
Applicator sprays a protective polyurea lining along the lower wall and floor transition of a corrugated grain bin.

ArmorThane's spray-applied polyurea linings form a seamless, flexible barrier between stored grain and the steel or concrete shell, helping keep moisture and acids away from the substrate. The coatings cure quickly -- tack-free in under 45 seconds -- which can shorten downtime compared with slower-curing systems. AquaSafe, the company's pure polyurea, is certified to NSF/ANSI 61 for potable-water contact and tested at 450 percent elongation (ASTM D-412), so the lining can flex with thermal movement and bridge minor cracks. Operators considering a lining for direct grain contact should confirm the appropriate product and specification with ArmorThane. For general bin and tank work, ArmorLiner bonds to metal, concrete, fiberglass, and wood.

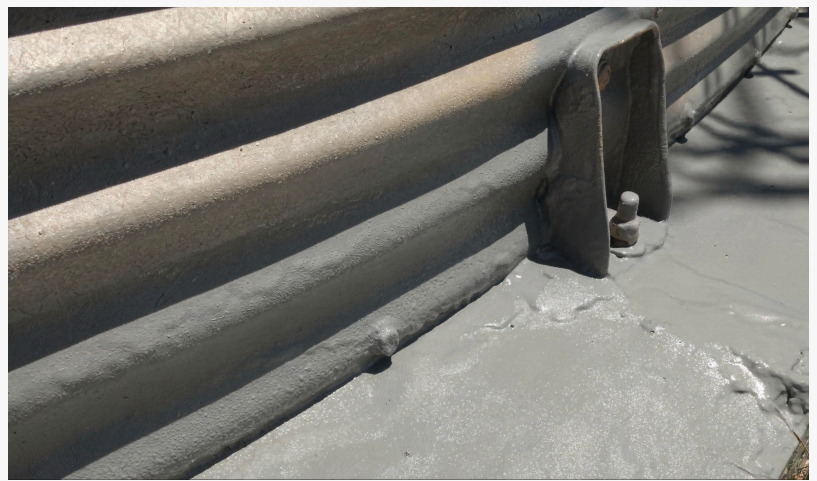
Detail of a coated grain-bin wall and floor transition after spray-applied polyurea lining.

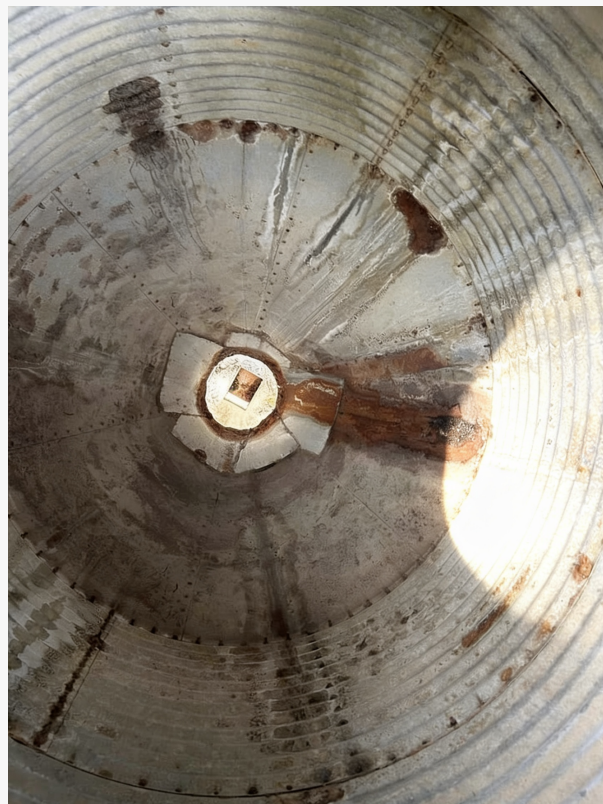
Interior view of a corrugated grain bin showing corrosion and staining before protective lining.

Bin corrosion often begins out of sight. Daily temperature swings cause condensation to form on interior walls, and that moisture can combine with grain dust and the organic acids in stored grain to corrode steel from the inside out. Over time, corrosion can thin bin walls, roughen surfaces so grain cakes and bridges against them, and open paths for the water intrusion that spoils stored product. By the
