Machine-Intelligent Pipe Inspection Technology Identifies Defective Service Tap Connections Missed by CCTV Inspection

Study Finds CCTV Cannot Reliably Judge Defective Tap Connections That Leads to Overstating the Responsibility of Property Owners as a Main Cause of Infiltration

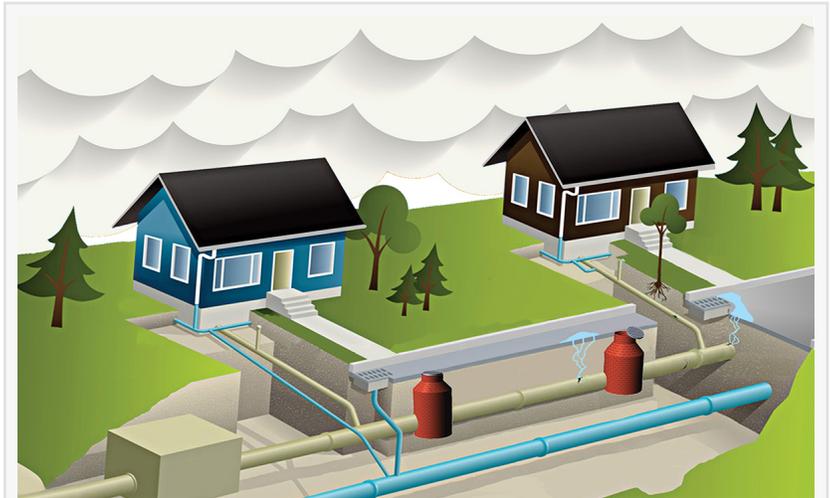
New machine-intelligent equipment has become a game-changer in how leaks can be precisely located & measured in sewer systems.
