# We4Ce patents its Re-FIT wind turbine blade root bushings, meeting demand for on-site repair

*60 percent cost-savings; Months of downtime avoided; Lifetime extension; Demand for onsite repair rising; Safety-critical part for bolts to connect to hub*

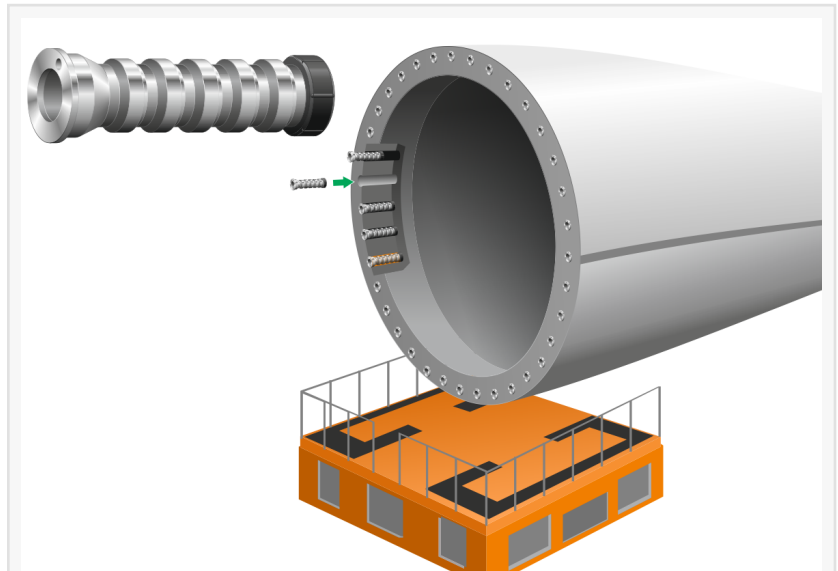
Following precision machining and extraction of the damaged bushing, the patented bushing is inserted into the rotor blade root which has been placed in a repair environment within the wind park

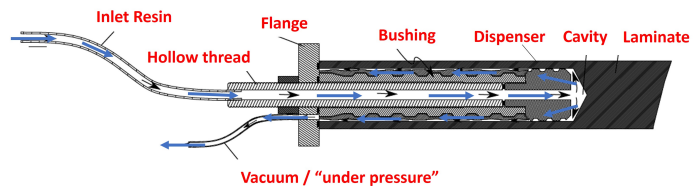
The patent covers the process of infusing epoxy resin into the bushing via an inlet tube. Using vacuum the resin is then distributed evenly around the outside of the bushing fixing it in place.

The patent covers the bonding method and design. An inlet tube placed into the hollow of the bushing is used to infuse epoxy resin into the extremities of the bushing where a proprietary steel resin dispenser has been fixed. The resin is then evenly distributed around the outside of the bushing using vacuum processing, which allows the bonding material to flow uniformly up towards the flange of the bushing. The chosen diameter of the circular dispenser aids the centering and precise placement of the component, previously a challenge.

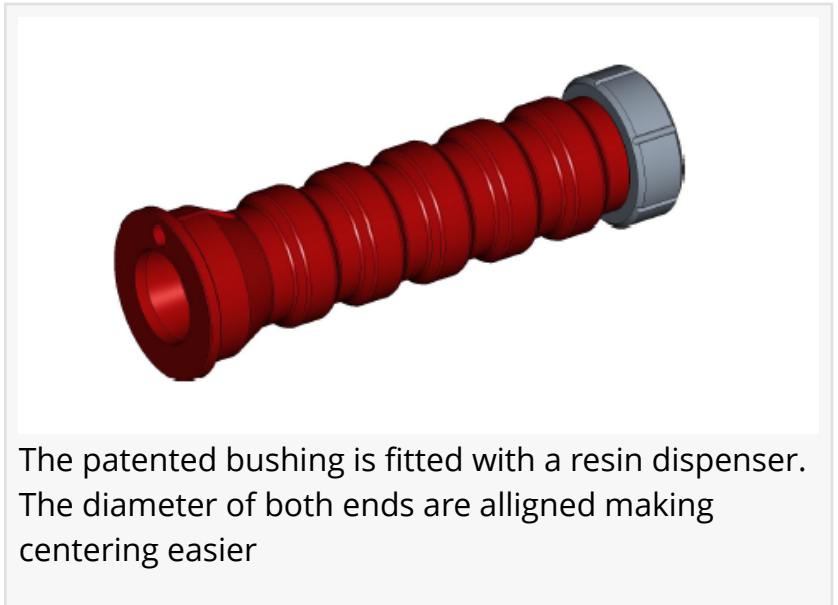
With the new repair method, the rotor blade is dismantled on-site and repaired in the wind park. The damaged bushings are extracted and replaced using precision machining. Multiple blade sets can be repaired within weeks.
