# CHASING X Industrial ROV Reveals Severe Pile Scour in Venezuela's Caroní River

*INMARVENCO used CHASING X in 4.5-knot currents to reveal severe scour at one pile while a nearby pile showed no comparable damage.*

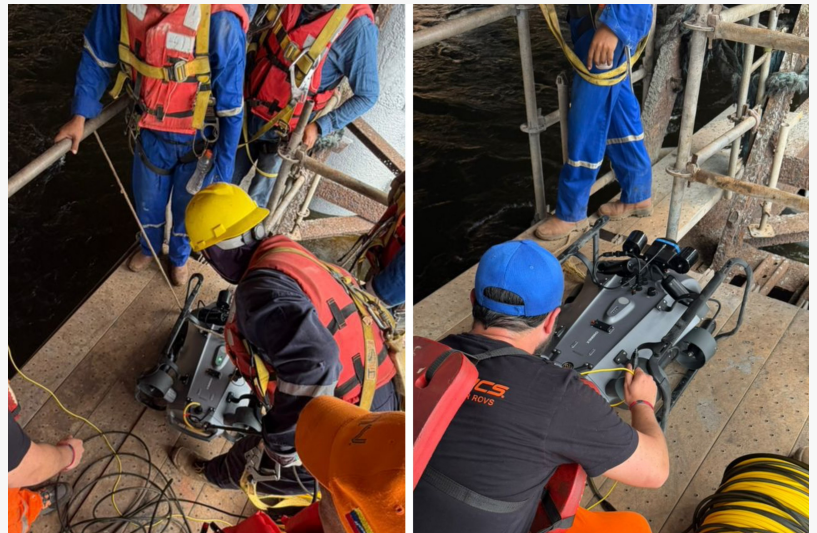
INMARVENCO technicians prepare the CHASING X industrial ROV for an underwater pile inspection in Venezuela's Caroní River.

CHASING X uses an OctoDrive eight-thruster vectored propulsion system and AnchorX omni-directional current resistance. During the project, these systems worked with DVL-assisted positioning and attitude control to support the inspection under peak 4.5-knot current conditions.

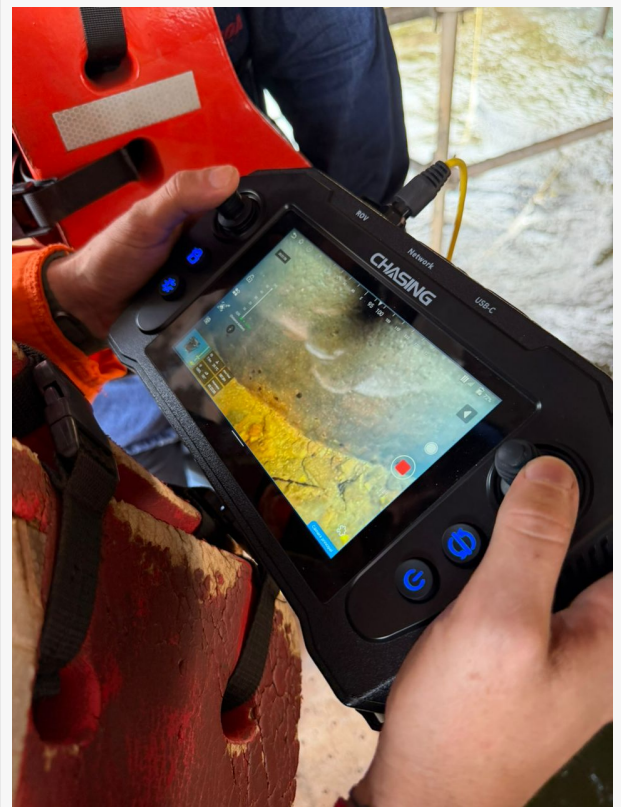
An operator monitors live underwater video from CHASING X during the Caroní River pile scour inspection in strong-current, low-visibility conditions.

INMARVENCO therefore adopted a sonar-first inspection workflow. An Oculus 750d multibeam imaging sonar generated acoustic images of the pile outlines, riverbed features and nearby obstacles. After areas of interest were identified, CHASING X moved closer to collect 4K video for visual confirmation.
