## American & British Water Utilities Adopt Electro Scan to Test New & Existing Trenchless Cured-In-Place Pipe (CIPP)

Outdated Visual Inspection of Widely Used CIPP Being Replaced By Machine-Based Technology to Locate & Quantify Leaks Missed by CCTV Cameras

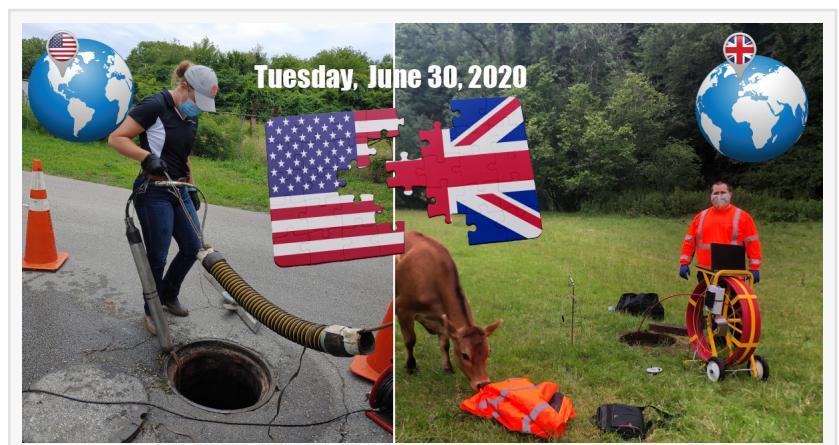
Hours apart, Electro Scan field crew members Mackenzie App in the United States and Brad Weston in the United Kingdom test Cured-In-Place Pipe (CIPP) showing the growing demand for machine-intelligent technology to test the watertightness of new and existing pipes.

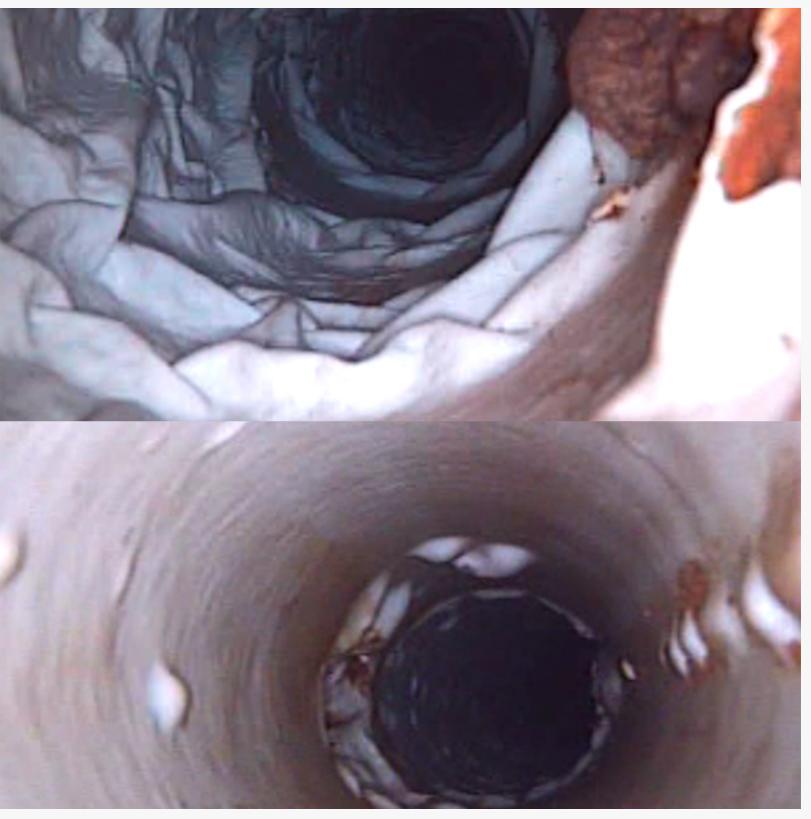
Defective CIPP liners in pressurized water mains.

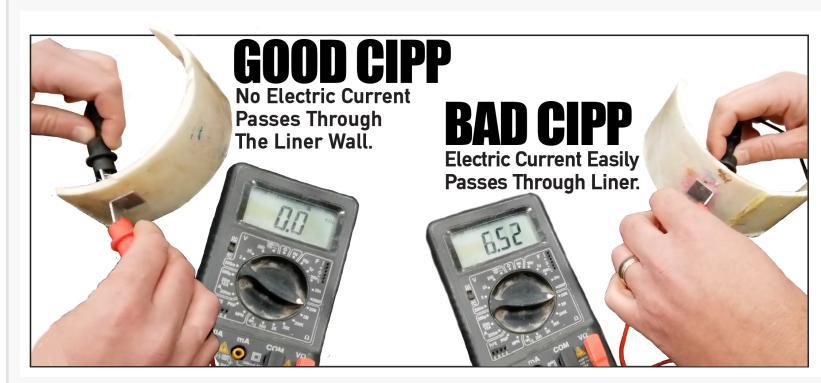
Low voltage conductivity allows utilities to automatically identify location and severity of defects in Cured-In-Place Pipe (CIPP) and other trenchless rehabilitation.

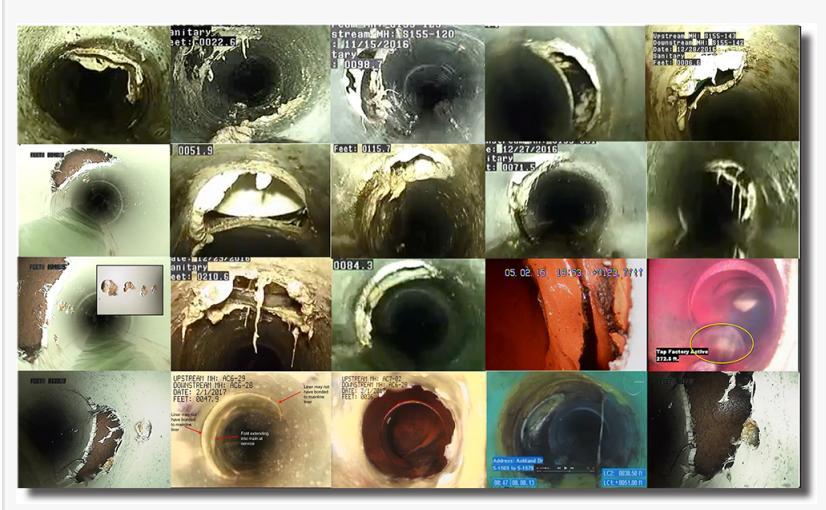
Example defective customer reconnections, after CIPP installation and lateral reinstatement.
