Royal Wood Floors Helps Milwaukee Home Owners Understand More About Problems and Causes of Hard Wood Floor Issues

Milwaukee hard wood floor company helps educate home owners on types of problems that can happen to hard wood floors and the causes.

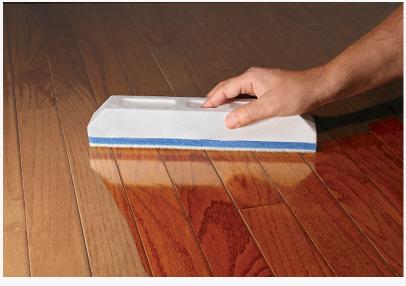
Bleed Back is a type of problem that can make hard wood floors less beautiful as well as Pin Holes, where problems like these can be fixed to keep floors from losing their natural beauty

Bleed Back is a problem that can occur that makes a hard wood floor look bad. It occurs when excess stain seeps up after it has been applied on open grain or the gaps between floor boards. The cause of this problem is excessive stain application. Also, high-viscosity or highly pigmented stain was applied to the floor. Another cause of this is that there was excessive heat in the environment during the drying period of the floor right after it was stained. Knot or burl areas can also cause this. There is a cure if you are experiencing this problem. If bleed back occurs before the finish is applied,

wipe off the excess stain or burnish/buff the floor with a white pad to remove the excess and even out the stain color. Then, let the stain dry thoroughly before applying another coat. If finish has already been applied over the top of bleed back, a complete re-sand of the floor is sometimes required. Trowel filling a floor may help reduce the potential for bleed back from very grainy wood. Cover the windows during the ap; application to prevent hot spots from occurring. A professional flooring company should know to do this. Then the stain should not be left to puddle for a long time before it is wiped off.

Pin holes are similar to fish eyes but very very small. The cause of this is a coat of finish being applied over the top of a coat that was not dry, or a finish coat applied to thick. Solvents are still evaporating and pushing through the finish that has already started to form a skin, leaving pin hole sized opening in the finish. This may also show in areas where the finish has puddled.

The floor should be given a sufficient time to totally dry, then abrade and screen and re-coat using the correct drying times between each coat. If you are doing this yourself you will always want to follow the manufacturers recommendations that also include the actual spread rates of the finish you are using. "The best way to make sure that your hard wood floors are protected and as beautiful as they naturally can be, is to always do the research first or seek professional help. Then problems such as the ones described here can be prevented," says Allman.
