Insulation Monitoring Ensures Electrical Safety in the Operating Room

HELSINKI, UUSIMAA, FINLAND, April 7, 2021 /EINPresswire.com/ -- Any electrical malfunctions in an operating room could be fatal. Insulation monitoring is the best way to guarantee electrical safety.

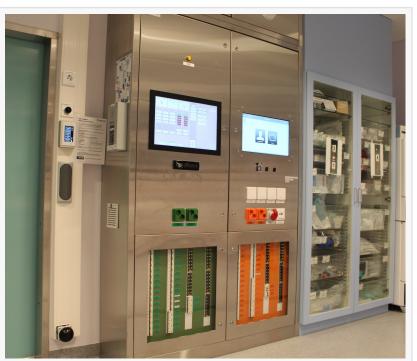
MEV-8 Insulation Monitoring System in the Finnish operating room.

This is how the MEV-8 Insulation-level monitoring system works •The operating room's electric power network is separated from the electrical grid by a medical insulation transformer. The insulation-level monitoring system monitors all the electrical devices connected behind this transformer. Units control the insulation level of the IT system, the transformer load, temperature, and the continuity of protective earth 24/7. •The equipment indicates the faults and problems before dangerous situations arise.

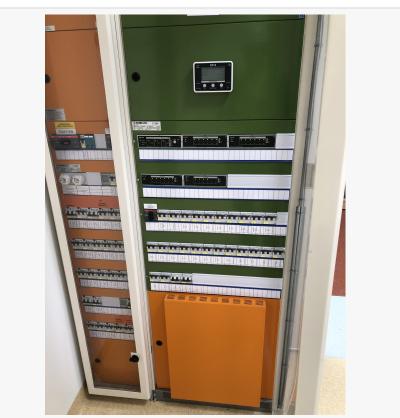
MEV-8 Insulation Monitoring System in an IPS rack

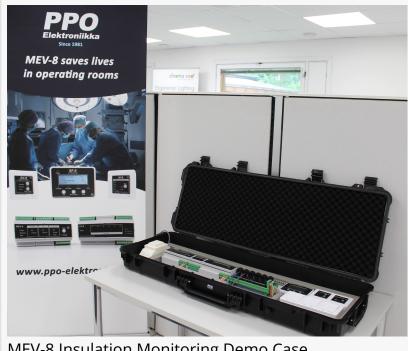
MEV-8 Insulation Monitoring Demo Case
