# Cracks, Bulges, and Patchwork Gone: ZD Stucco Repair Revives Barnegat's Fading Condos

*ZD Stucco Repair revitalized Little Beach Condos in Barnegat, fixing cracks, bulges, and improper patches with expert stucco restoration and a new finish.*

CLIFTON, NJ, UNITED STATES, October 4, 2024 /EINPresswire.com/ -- ZD Stucco Repair is proud to announce the successful completion of a comprehensive stucco restoration and maintenance project at the Little Beach condos, a 40-unit residential complex in Barnegat, New Jersey.

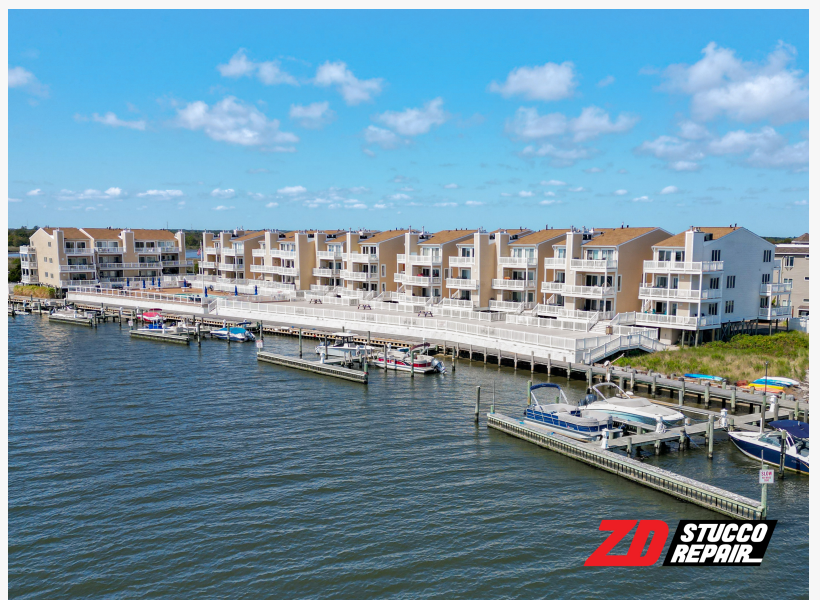
Fully restored Little Beach condos in Barnegat, NJ

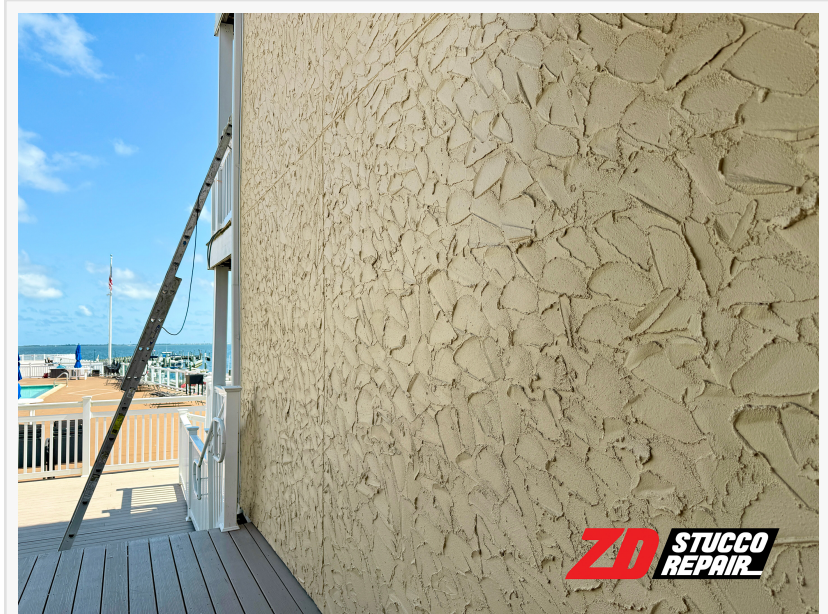
Sophisticated texture restored and matched by ZD Stucco Repair

- Texture matching: Seamlessly matching the texture of the new stucco with the existing surfaces for a uniform appearance.

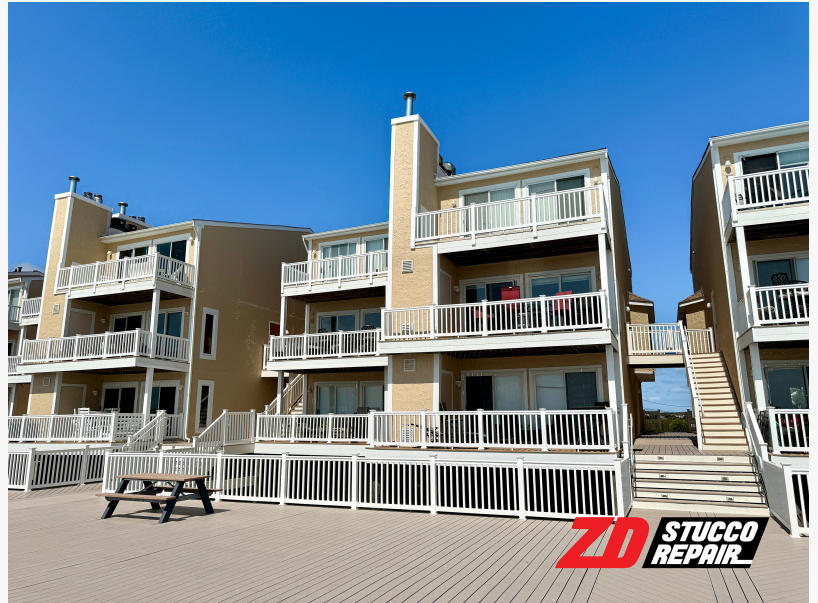
Final look of a building that is part of the condo complex
