Pathmaker Plumbing Prevents Dangerous Carbon Monoxide Leak During Water Heater Repair

Pathmaker Plumbing of Charlotte prevented a dangerous carbon monoxide leak caused by improper PVC piping installation during a water heater repair.

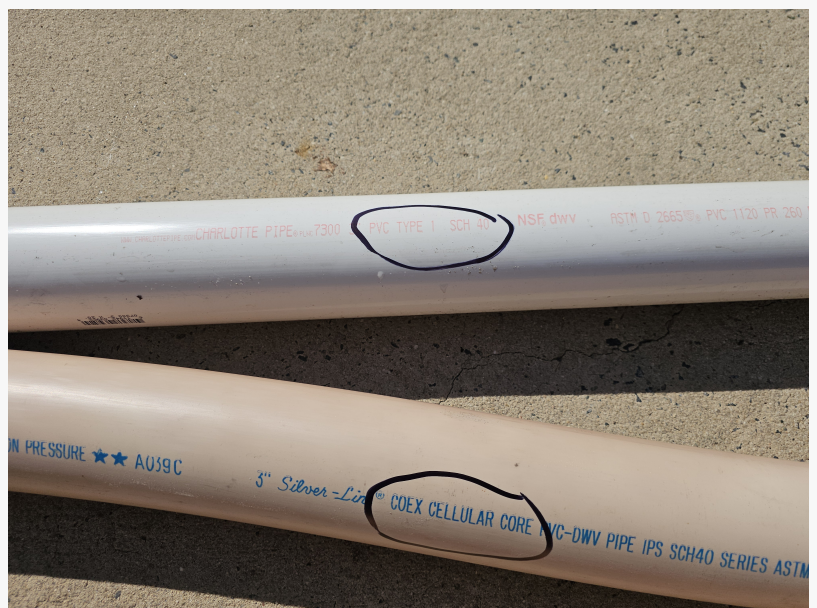
The type of PVC used in the original installation is not recommended for use as a water heater vent because it can bend and break down when it becomes exposed to

Comparison of types of PVC piping

heat, leading to serious safety risks. Carbon monoxide is a particularly dangerous threat. It's considered to be highly toxic even in small amounts. Not all PVC is created for the same purpose. There are different types for different installations and having a licensed and qualified plumber who knows the difference can sometimes be the difference between life and death.

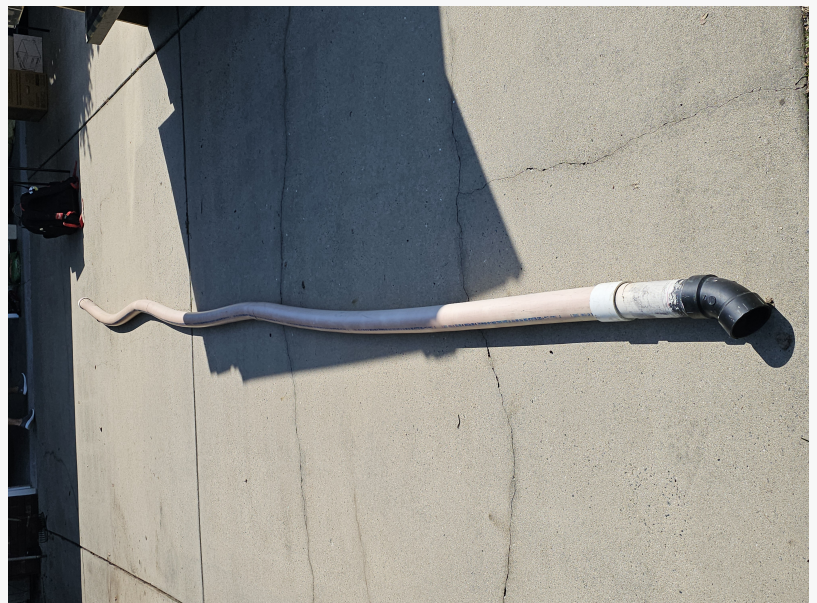
The homeowners mentioned to the Pathmaker team that the room above where the water heater was located was occasionally occupied by their son. The team went on to inspect the attic floor adjacent to the bedroom where they found that PVC piping was used as the old water heater vent. The piping had broken apart and had been steadily filling the bedroom with carbon monoxide.

PVC pipe bent from water heater

Stokes and the Pathmaker team immediately removed the broken and improper piping and replaced the old water heater system with a more efficient tankless water heater. This installation will ensure the home stays safe and protected. The family now enjoys a reliable hot water system without the looming threat of carbon monoxide poisoning.

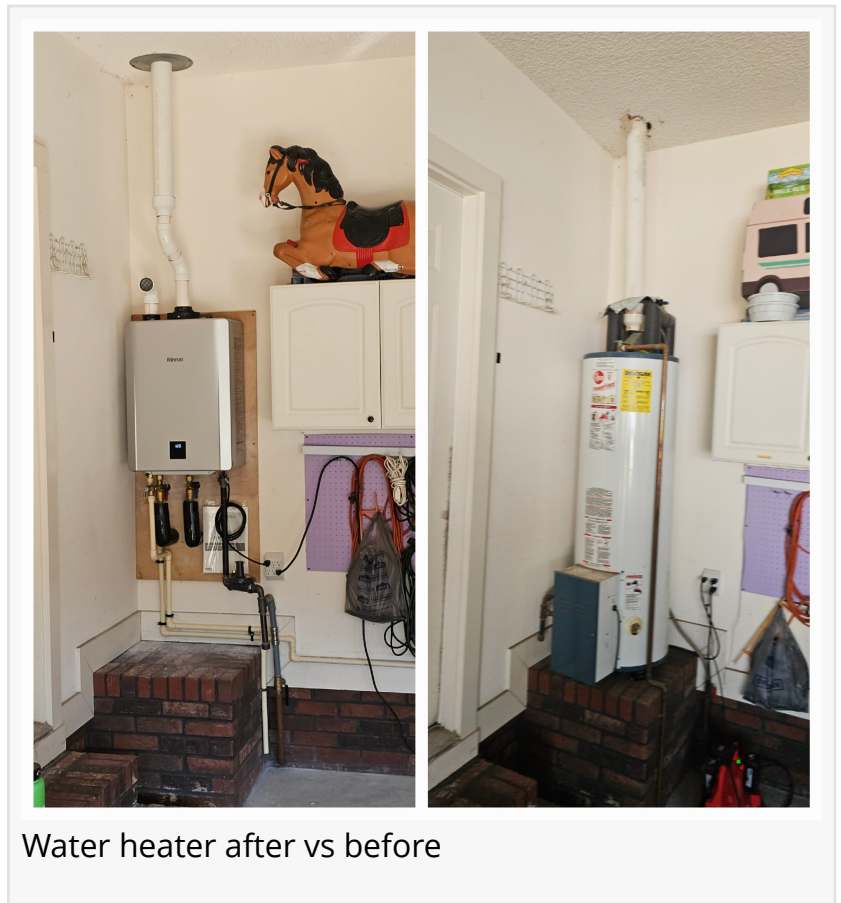
John Stokes, the owner of Pathmaker Plumbing, was immediately concerned after finding the condition of the PVC piping. "Carbon monoxide is deadly. Homeowners often don't even realize the danger they've been put in from improper water heater installations," he shared. "We're very glad we were able to catch this for them before it turned into a worse situation."
