Moorestown Home Restored by ZD Stucco Repair, Just in Time for Summer Fun

ZD Stucco Repair successful completed a full-home stucco repair and restoration project on a spacious 4,600-square-foot single-family home in Moorestown, NJ.

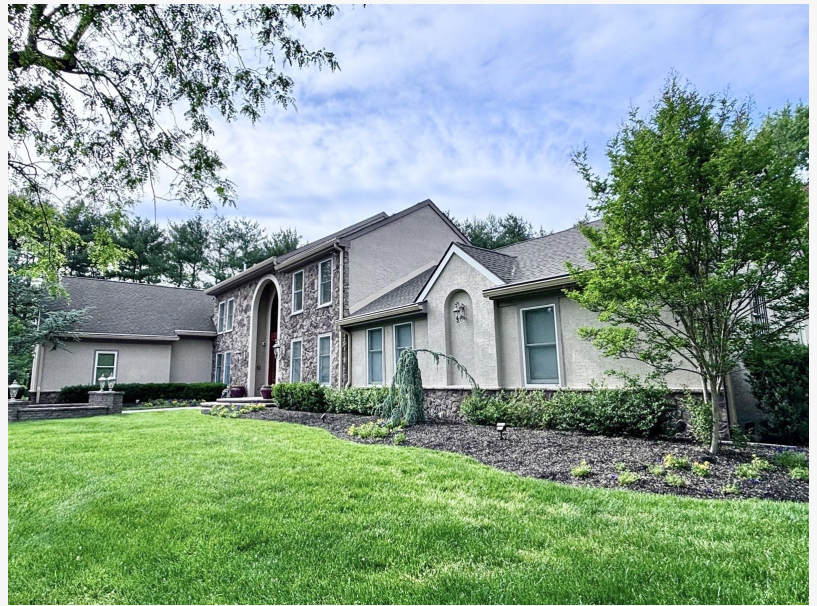
Fully restored stucco home in Moorestown NJ

The project began with a full power washing of the stucco exterior, followed by the restoration of missing sections using custom-textured applications to seamlessly match the original finish.

Cracks were repaired with flexible mortar-textured caulking, and all expansion joints, window perimeters, and exterior penetrations were resealed with high-performance elastic sealants.

Finally, the team applied a full coat of premium [elastomeric stucco paint](#), delivering long-lasting protection and a refreshed, beautiful

appearance.

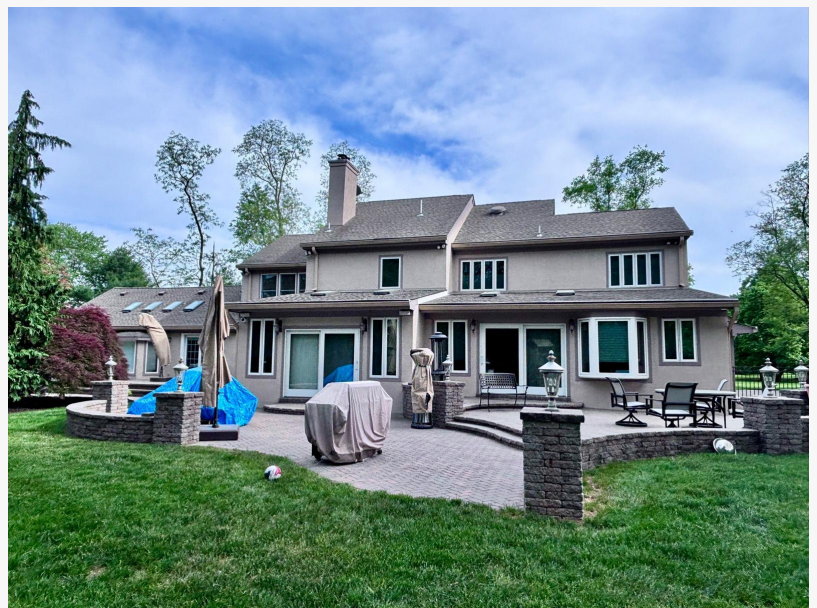
Back side of the Moorestown home
