BMW X5 Carbon Buildup and Clogged Injectors Repaired in Hollywood

German Car Depot diagnoses and repairs BMW X5 carbon buildup, clogged injectors, and fouled spark plugs for Euro owners in Hollywood and Fort Lauderdale.

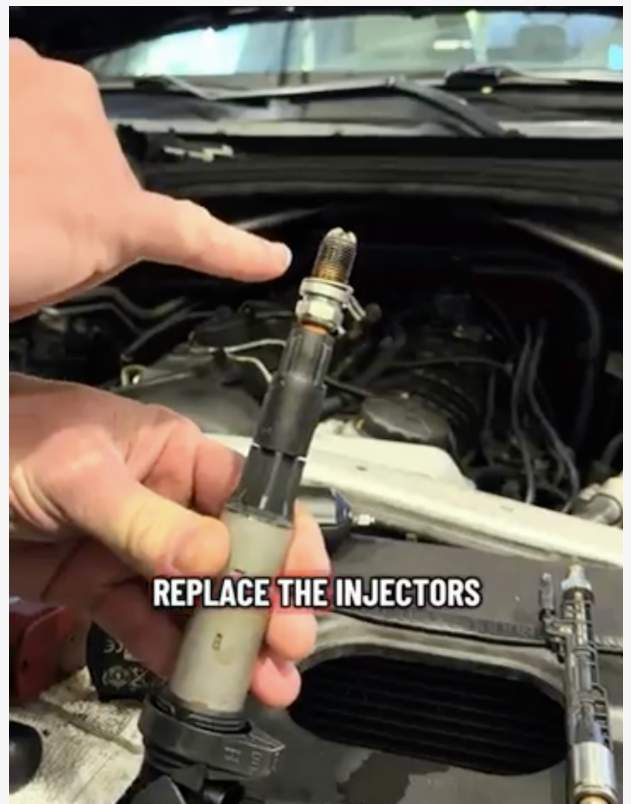
In this featured repair case, the BMW X5 presented with drivability complaints including misfires and reduced power. Upon inspection, technicians identified heavy carbon buildup, partially clogged injectors, and worn spark plugs. The team performed a thorough intake cleaning, injector service, and ignition component replacement to restore proper engine performance.

BMW X5 Spark Plugs with Carbon Buildup causing engine misfire codes.
