# ZD Stucco Repair Completes Full Exterior Restoration for Wells Fargo in Clifton NJ

*Major Route 3 project replaced a compromised wall system with new plywood, waterproofing, insulation, flashing and a complete EIFS exterior.*

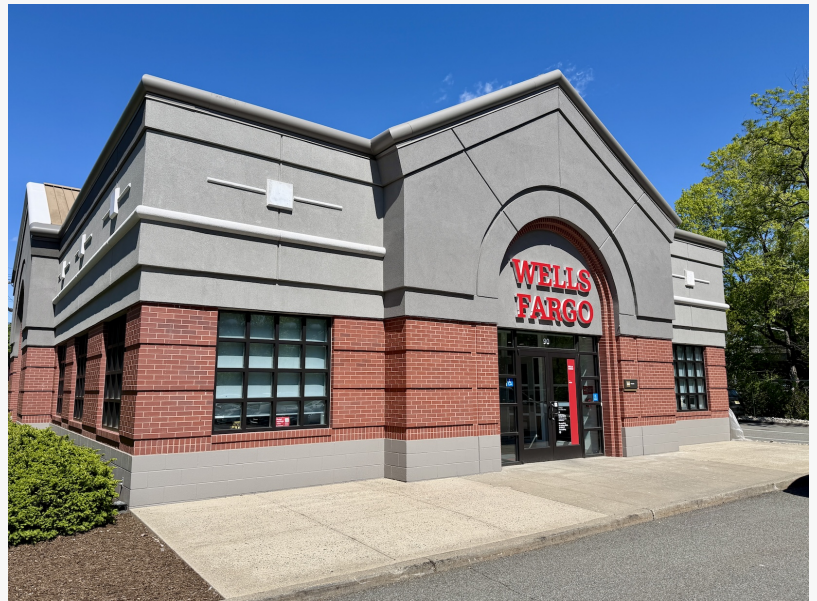
Wells Fargo in Clifton gets a brand new exterior

Rather than covering the visible damage with temporary repairs, the existing stucco system was removed and the exterior was rebuilt completely. ZD Stucco Repair replaced more than 60 sheets of compromised plywood with new code-compliant sheathing, installed a liquid-applied waterproofing system and constructed a new Dryvit [EIFS assembly](#).

The finished building retains its familiar architectural character with a refreshed gray exterior that complements the original red brick. Beneath the new appearance is a modern wall system designed to improve moisture protection, insulation and long-term durability.

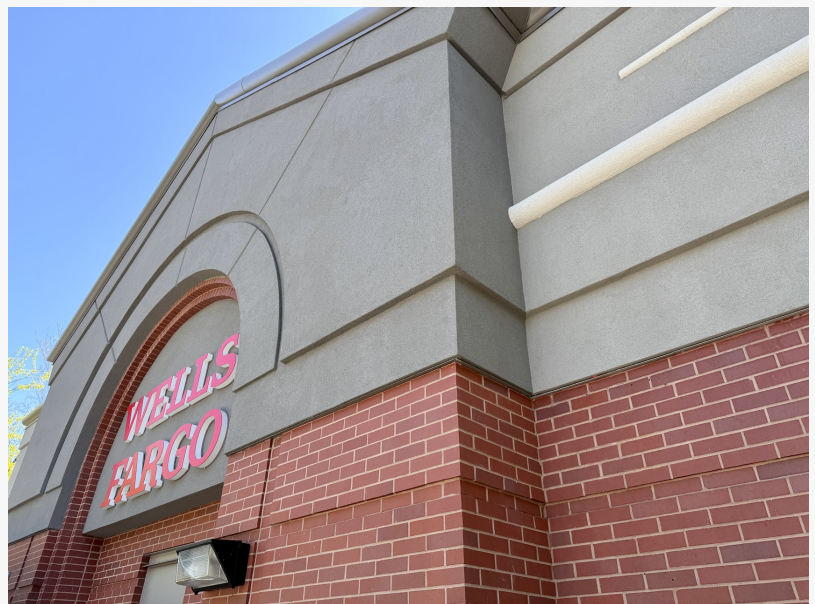
New EIFS system

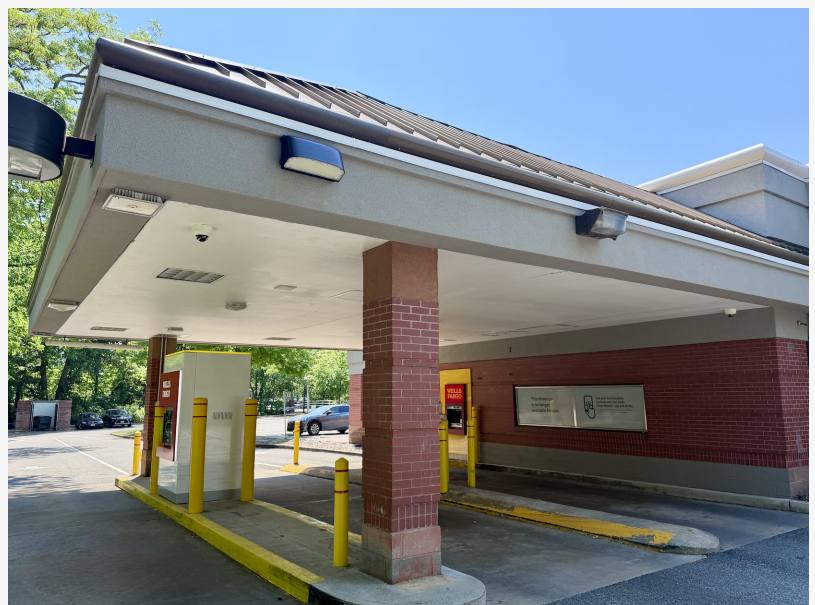
Wells Fargo drive-through
