# Western Specialty Contractors Performs Parking Deck Repair Project in San Antonio

SAN ANTONIO, TX, UNITED STATES, August 19, 2026 /EINPresswire.com/ -- Western Specialty Contractors' [San Antonio branch](#) is performing a [concrete repair and strengthening project](#) at a [parking structure](#) in San Antonio, TX.

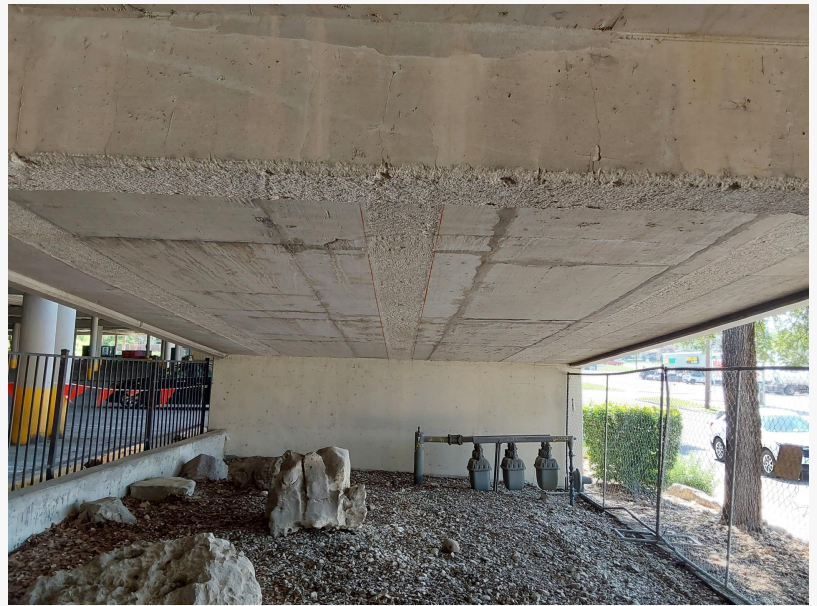
Parking deck repairs

Serving as the prime contractor and working with Walker Consultants, Western is completing a comprehensive scope of repairs designed to improve the structural performance and extend the service life of the parking deck. Work includes installing fiber-reinforced polymer (FRP) strips on the underside of concrete slabs, concrete beam enlargement, overhead and vertical concrete repairs, rout-and-seal crack repairs and crack injections.

Additional work includes repairs to connection joints at double-tee members, double-tee flanges, and horizontal concrete surfaces, as well as repairs to loose barrier cables and the removal of parking blocks.

To accelerate the installation of the FRP strips, Western utilized a boom lift to access the underside of the slabs. Because the FRP installation process involves resins and adhesives that could damage or contaminate the equipment, the crew developed a practical solution to protect the lift. The boom lift basket was wrapped in plastic sheeting, while Ram Board was installed on the basket floor to protect it from epoxy spills and simplify cleanup.
